# VEHICLE INSPECTION REPORT

**DK69WJJ**

## Isuzu N75 190

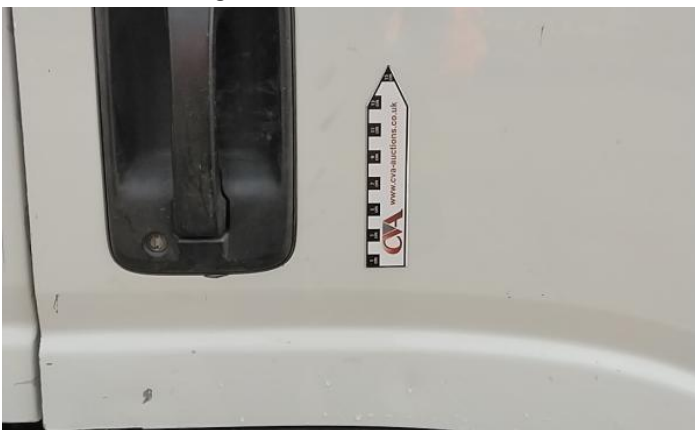
13: Door osf  
Dented  
Between 10mm + 30mm

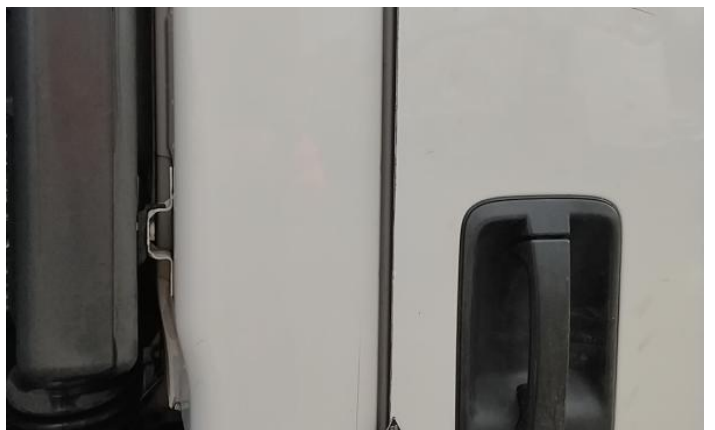
14: Door osf  
Chipped  
Multiple Chips

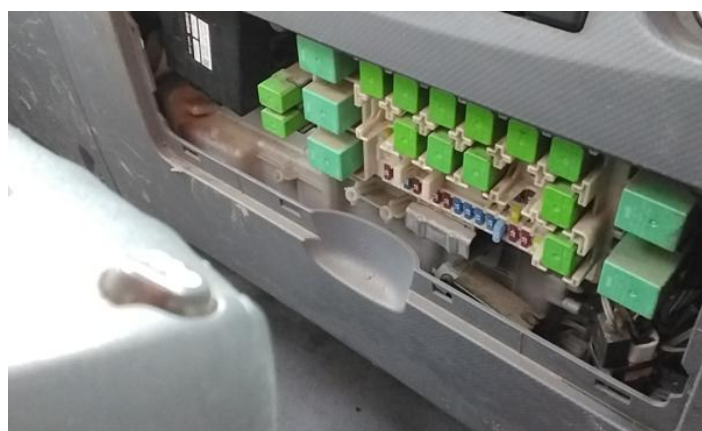
18: Centre Console Front  
Missing  
Replace
