# VEHICLE INSPECTION REPORT

**NL69ESV**

## Scania G 450

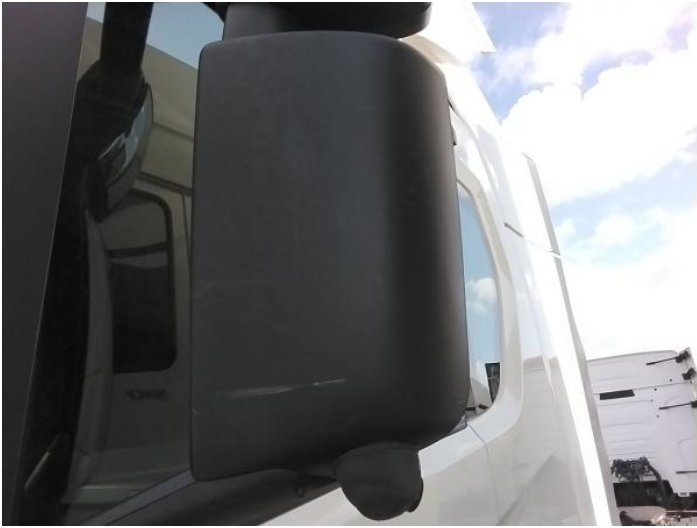
3: Door Mirror Assy nsf  
Scuffed (Unpainted)  
Over 100mm

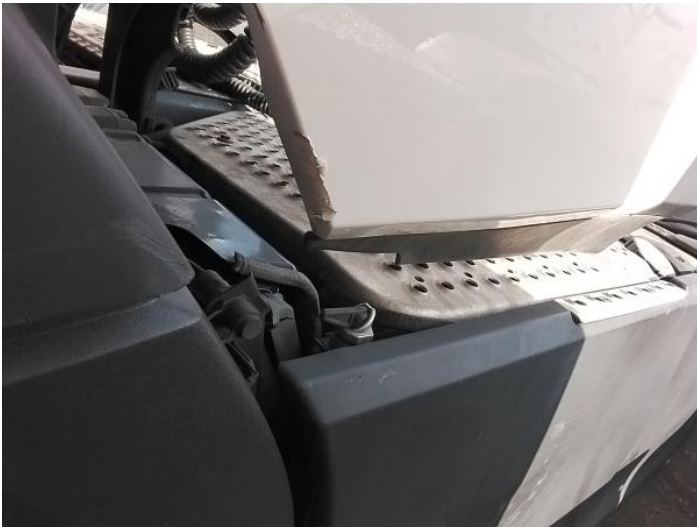
5: Qtr Panel Trim nsf  
Scuffed  
Over 25mm

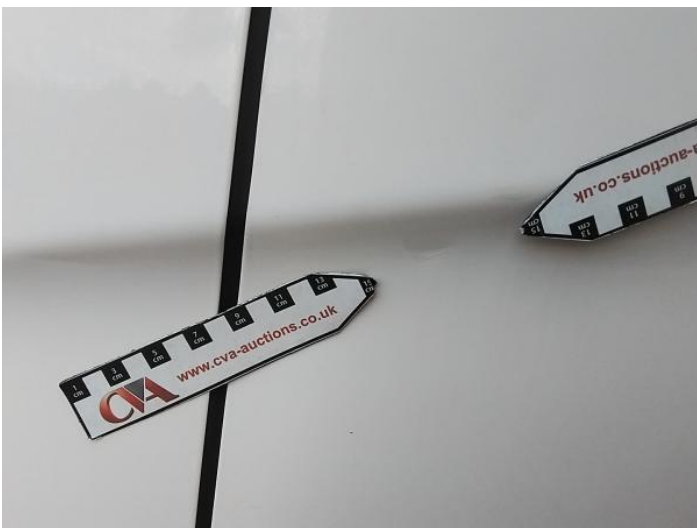
7: Door nsf  
Dented  
Over 30mm
