VEHICLE INSPECTION REPORT

HU54MKM

Iveco EUROCARGO 180E

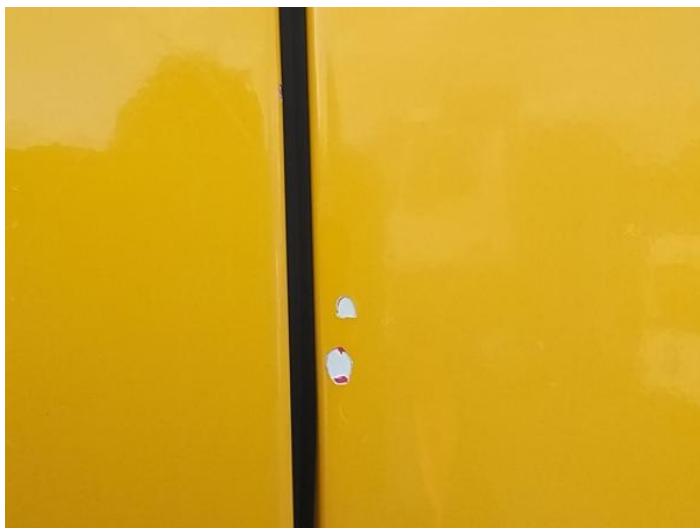
1: B Post ns
Chipped
Over 5mm

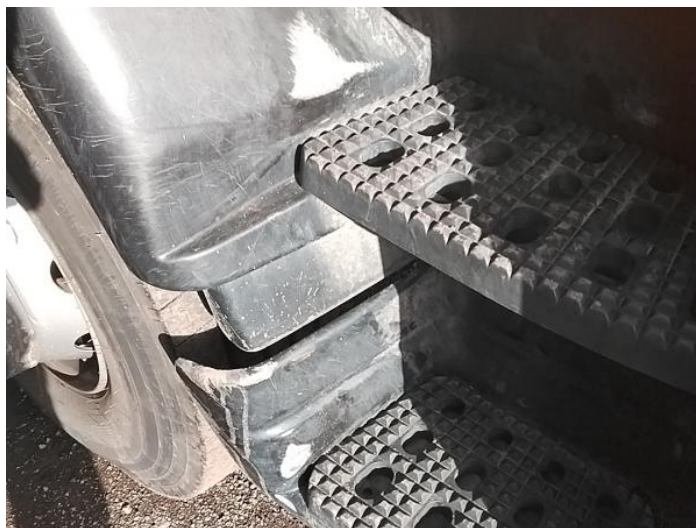
2: Moulding of Wing
Scuffed (Unpainted)
Over 100mm

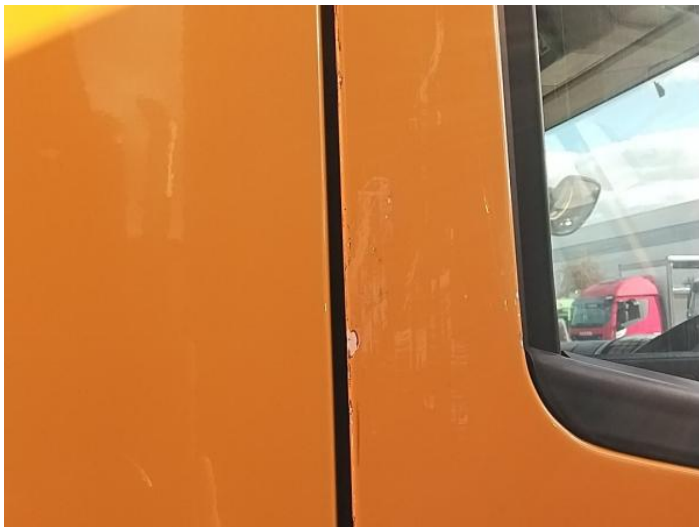
3: Door osf
Chipped
Edge Chip

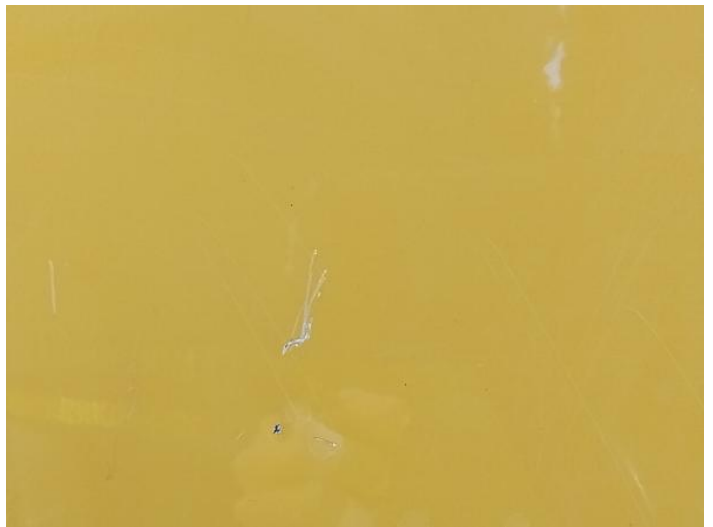
4: Door osf
Scratched
Over 25mm Thru Paint

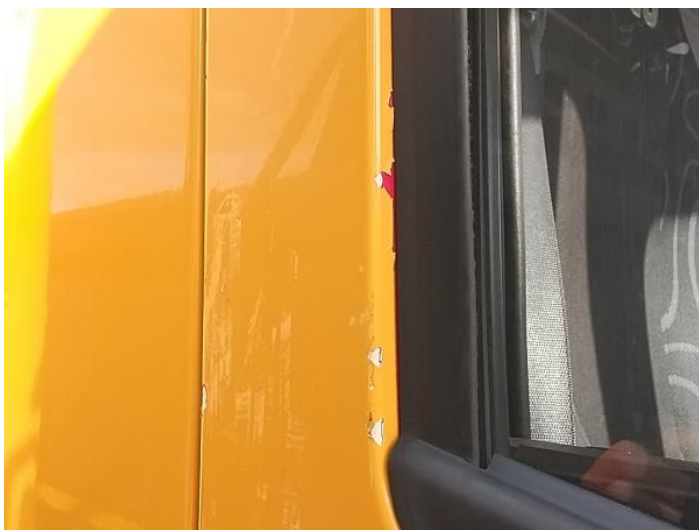
5: Door osf
Chipped
Multiple Chips
